### Ballistic Witness – School Safety Video

### Report No.: E9327.01-401-47

### SAINT-GOBAIN SOLAR GARD, LLC

**PRODUCT TYPE:** Safety and Security Window Film

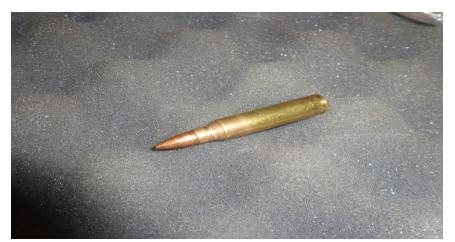
Photo No. 4 Specimen #2 .223-556 mm. Ammunition

**Note 1:** The rifle utilized was a Bushmaster model # XM15-E25, .223-556 mm. The ammunition utilized was full metal jacket.

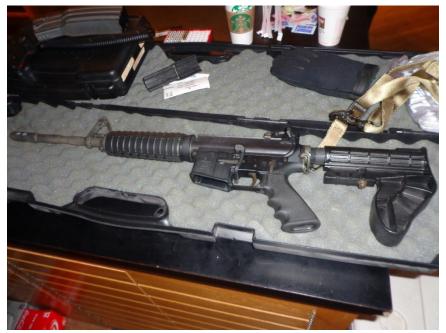
Photo No. 5 Specimen #2 Bushmaster Model # XM15-E25

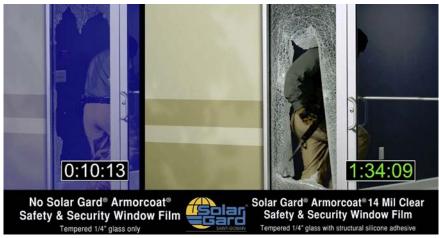
Photo No. 9 Specimen #1 on Left Half of Screen Specimen #2 on Right Half of Screen Intruder – With Film 4 This photo was added at the request of the client and was not taken or reproduced by Intertek/ATI.
